Manhole Inspection Summary

Manhole # S15II2001MH

Location Address: **6112 MAYWOOD AVE**

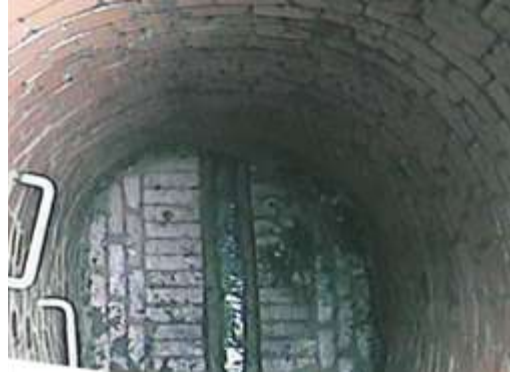
Top View

Bench debris.

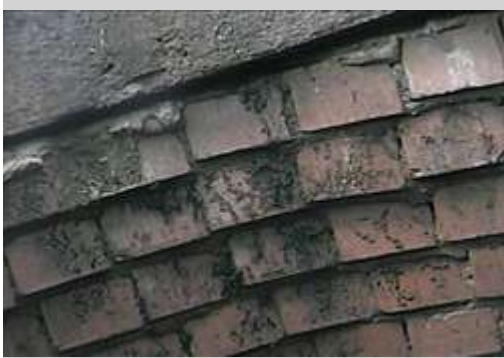
Defect

Frame Offset: **0** (in.) Condition: ☐ Sound ☐ Cracked ☒ **Leaks**

Condition: ☐ Sound ☐ Cracked ☐ Root Intrusion ☐ Loose Brick ☒ **Deteriorated**

Infiltration: ☐ None ☒ **Joint** ☐ Cracks ☒ **Mortar** ☐ Roots ☐ Wall

Infiltration: ☐ None ☐ Joint ☐ Cracks ☒ **Mortar** ☐ Roots ☐ Wall

Frame leaks. Adjustment and Corbel deterioration and infiltration.

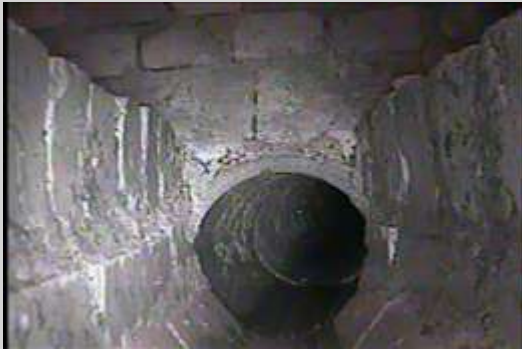
8 in. Circular Gravity Sewer Pipe Out @ 12 O'Clock

Infiltration: **Evidence** Pipe Seal Cond: **Cracked**

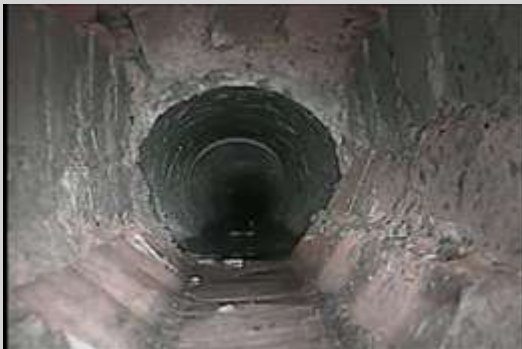
8 in. Circular Gravity Sewer Pipe In @ 6 O'Clock

Infiltration: **Evidence** Pipe Seal Cond: **Unknown**
